# PROJECT REPRESENTATIVE'S DAILY REPORT

Pg. 1  
Report No. 070  
Date: 2014-11-26  
Day: Wednesday

**Project:** Renovation and Addition to Tewksbury Town Hall

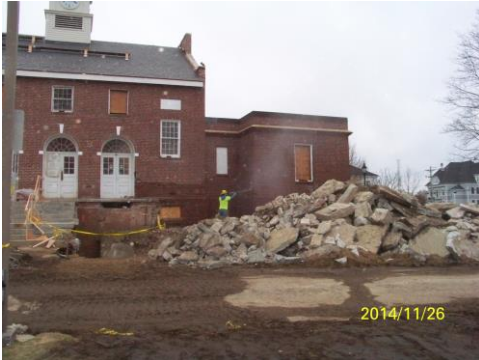
Photo showing mason washing down the east elevation.

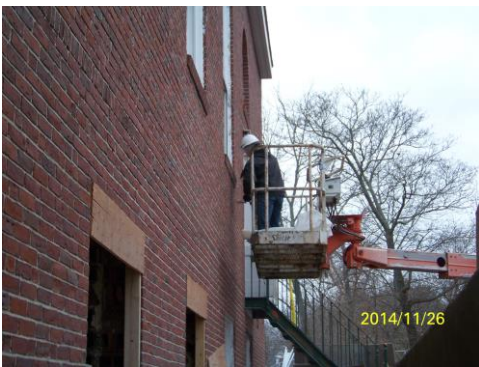
Photo showing mason pointing on the north elevation of the meeting hall.

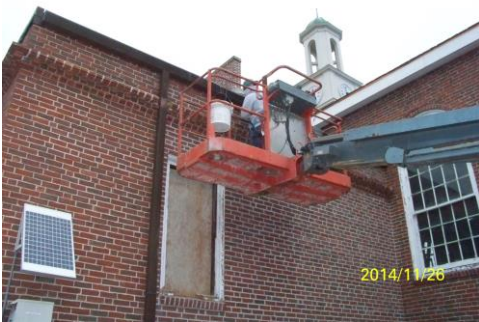
Photo showing mason pointing on the west elevation of the north wing.

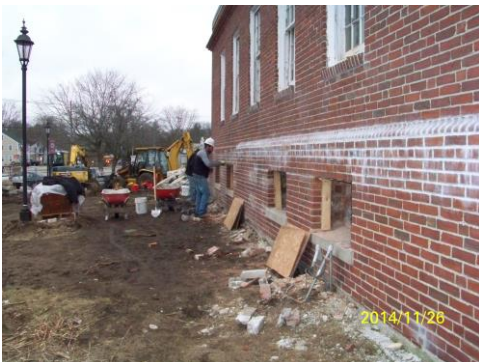
Photo showing masons pointing on the north elevation of the north wing.

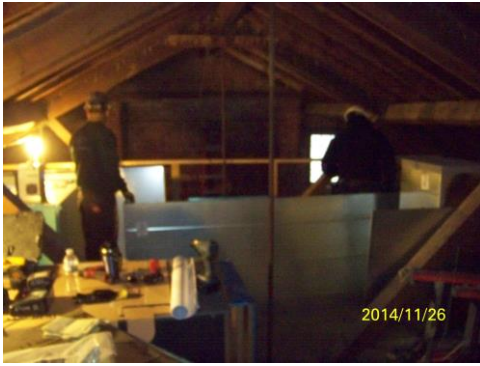
Photo showing HVAC workmen assembling the equipment in the attic.

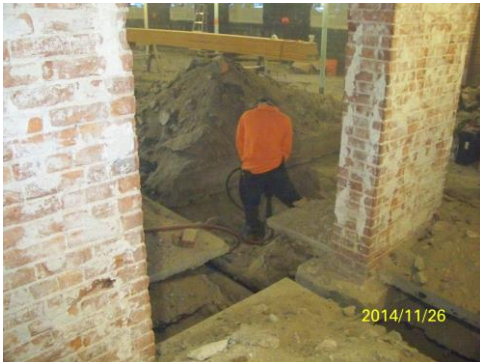
Photo showing workman breaking up a section of subsurface concrete slab.

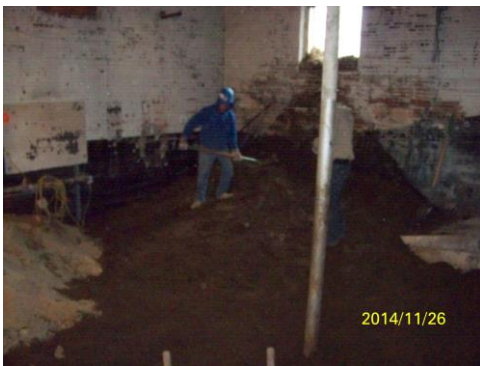
Photo showing workmen spreading and backfilling the mechanical room.

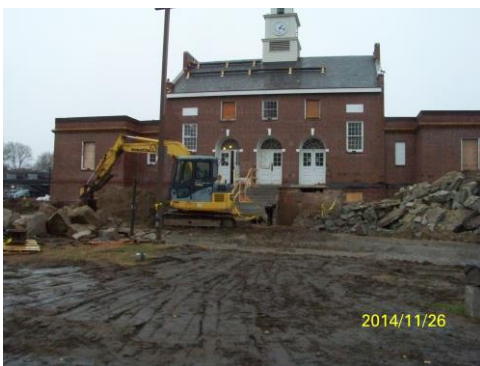
Photo showing backfilling of drain pipe trench at the east elevation.

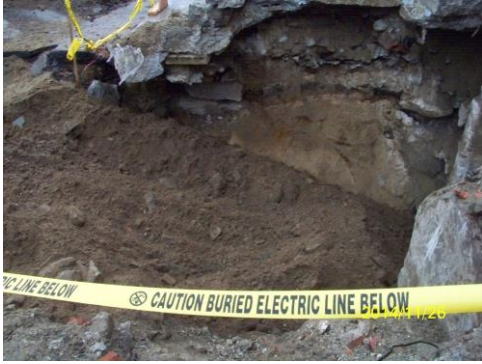
Photo of trench being backfilled.

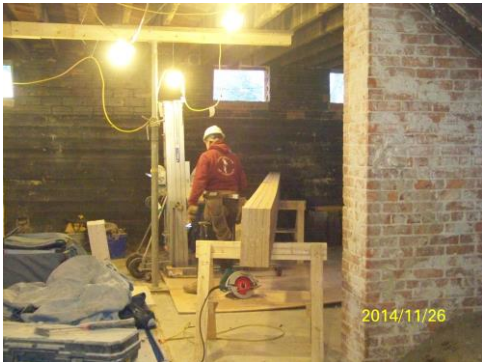
Photo showing carpenter assembling (3) LVLs for installation for the first floor framing.

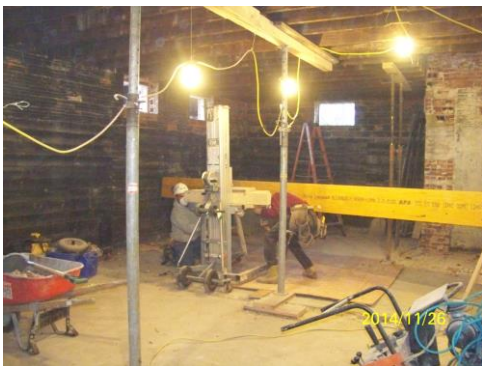
Photo showing carpenters assembling (1) of the LVL beams.

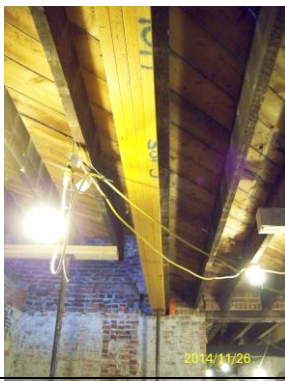
Photo showing LVL beam in place.
